RBC

Remediation

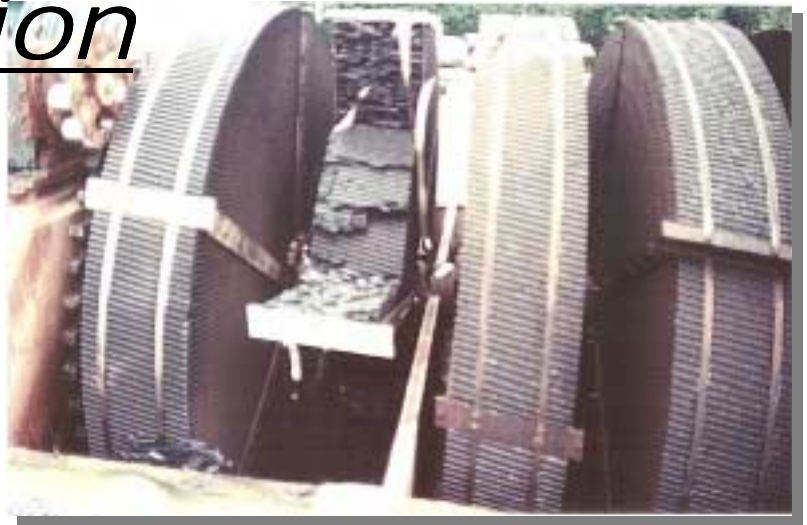
Collapsed Rotor Assembly

The Cranfield research revealed that RBCs failed in fatigue exacerbated by slow rotation

in an aggressive environment. Their study identified the correct fatigue stresses at a specified biomass thickness and speed of rotation.

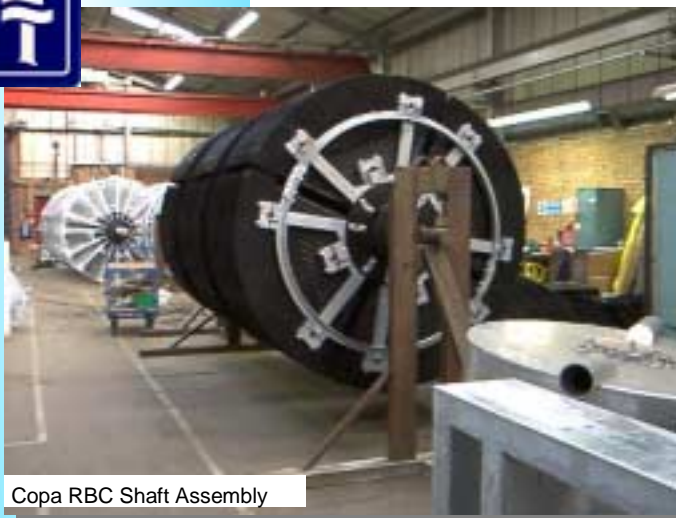
Copa RBC Shaft Assembly

The Cranfield/Tomkinson rotor design incorporates many features that reduce fatigue stresses to ensure a minimum 20 year life making the process extremely robust and cost effective. The process is simple to operate with a low energy requirement.
