Manufacturing High Quality Rotating Biological Contactor's for the UK Water industry

D. Mba¹, R.H. Bannister¹ and G.E. Findlay²

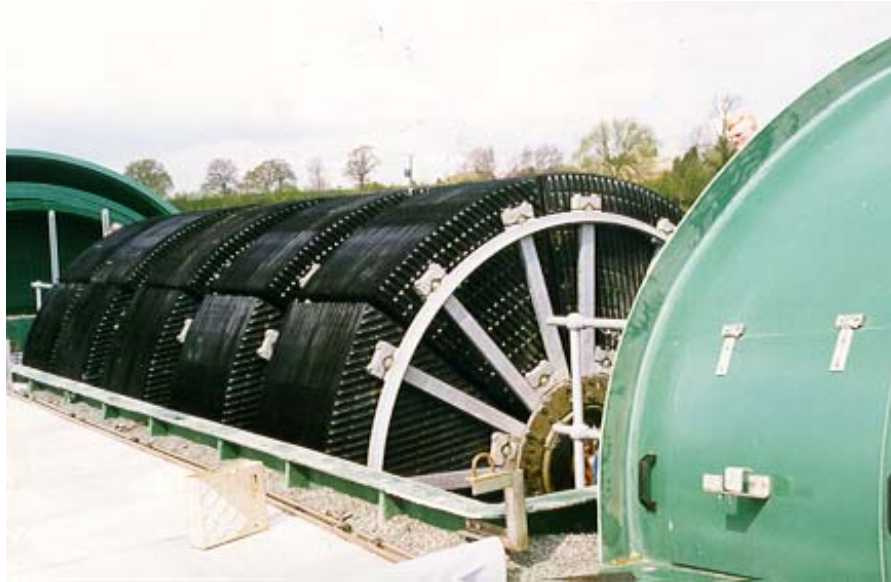
Figure 1 Typical Rotating Biological Contactor

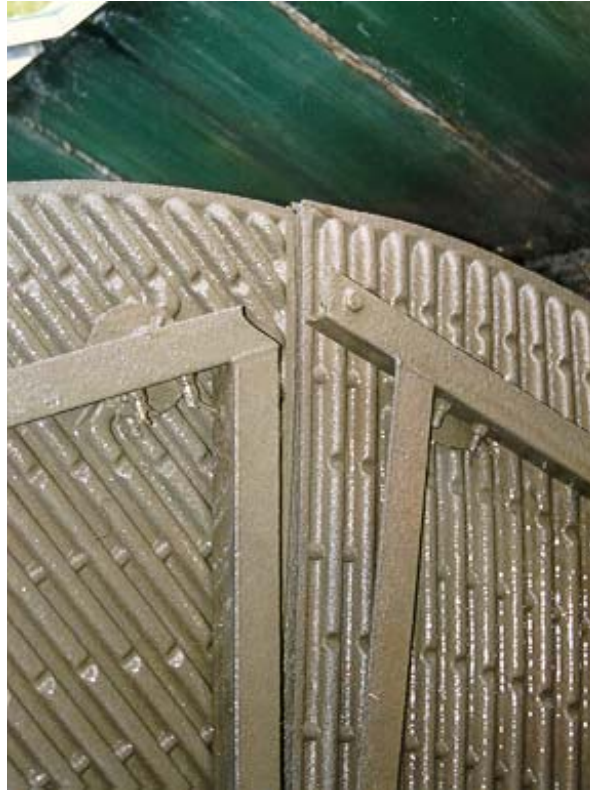
The RBC media support structure generally consists of between four to twelve equal segments which are contained within a common frame, dependent on the size of the RBC. Each individual segment is usually supported by three through rods attached at their ends to a supporting structure. Fatigue failure of this structure has been experienced, particularly on the larger RBC's, see figure 2

Figure 2 Damaged media support structure

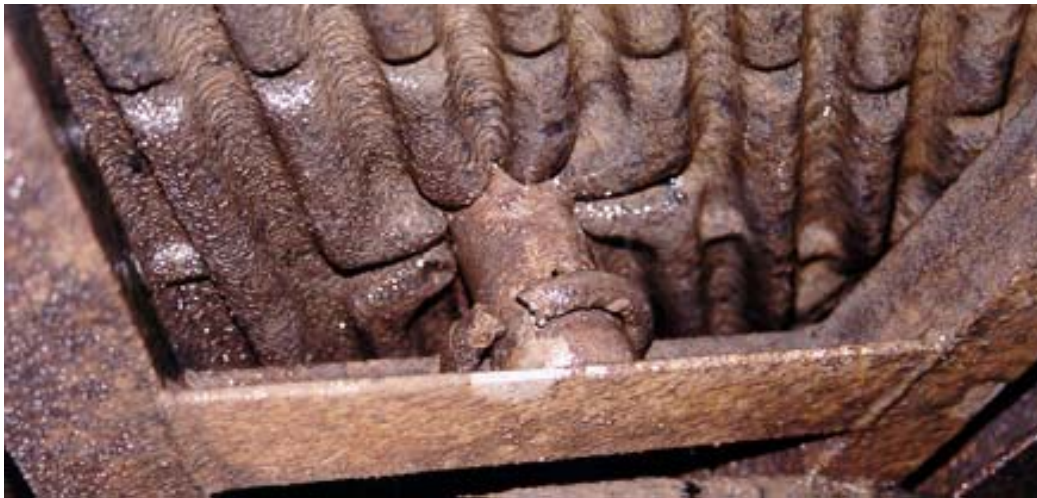
Many RBC's employ 'U' shaped bolts, or straps, to clamp the media supporting rods onto the supporting structure. It is common for these bolts/straps to suffer from fatigue fracture, particularly on the first and second media pack where the biomass loading is greatest, see figure 3.

Figure 3 Fractured 'U' strap

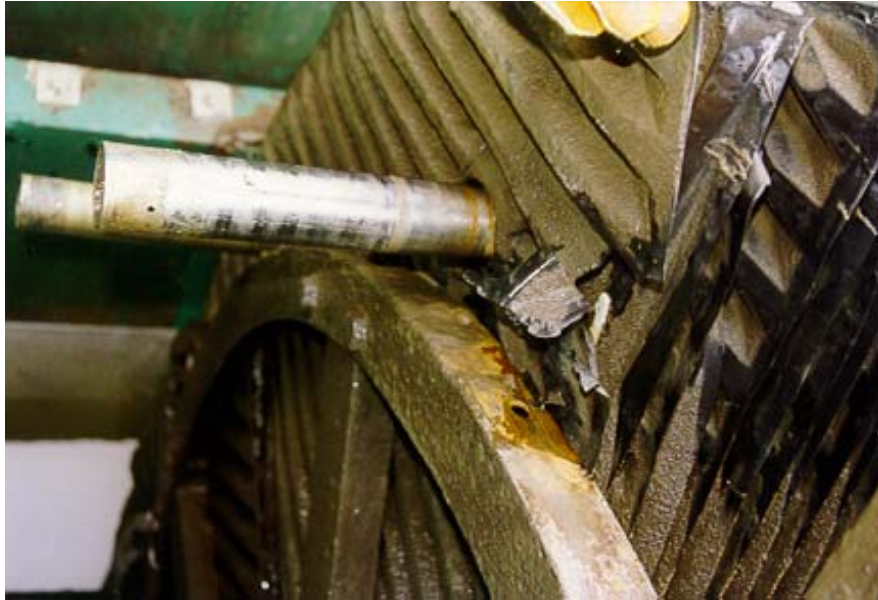
In addition, clamps securing the through rods to the supporting frame have in many instances lost their clamping efficiency, as a result of inadequate design. In several instances this has resulted in the through rod becoming loose and moving axially along the length of the rotor, eventually catching the concrete or GRP basin/tank, resulting in major damage, see figure 4.

Figure 4 Loss of clamping efficiency resulting from a fractured 'U' strap

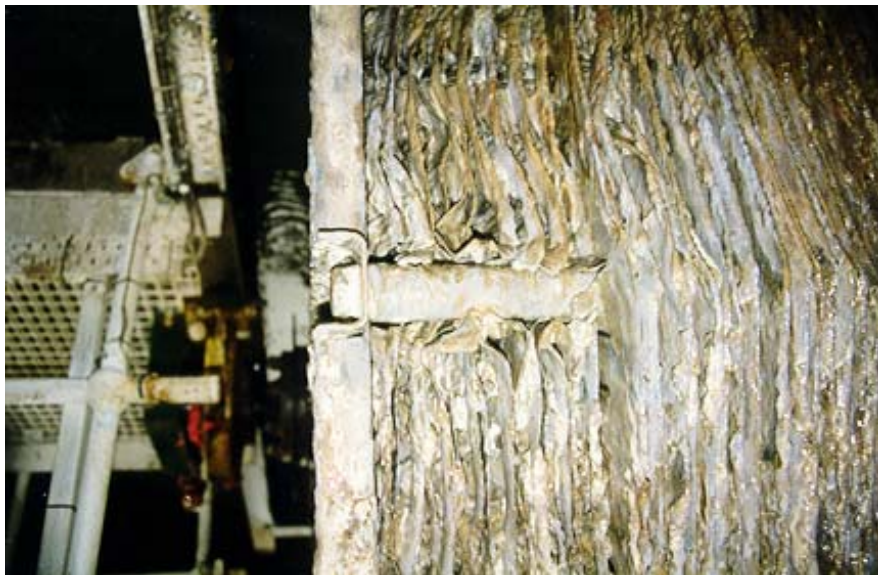
Tearing, loss of rigidity and crumbling of these media panels are common and highlighted in figures 5 and 6, depicting mechanical inadequacies in designs of media panels. Tearing generally occurs in the region through which the support/through rods pass and is attributed to Hertzian stress concentrations in the vicinity of the through rod hole. In addition, poor quality of finish during manufacture results in the creation of jagged edges giving rise to stress concentrations, which eventually lead to crack growth and tearing in this vicinity, see figure 7.

Figure 5 Tearing of high-density polypropylene media panels

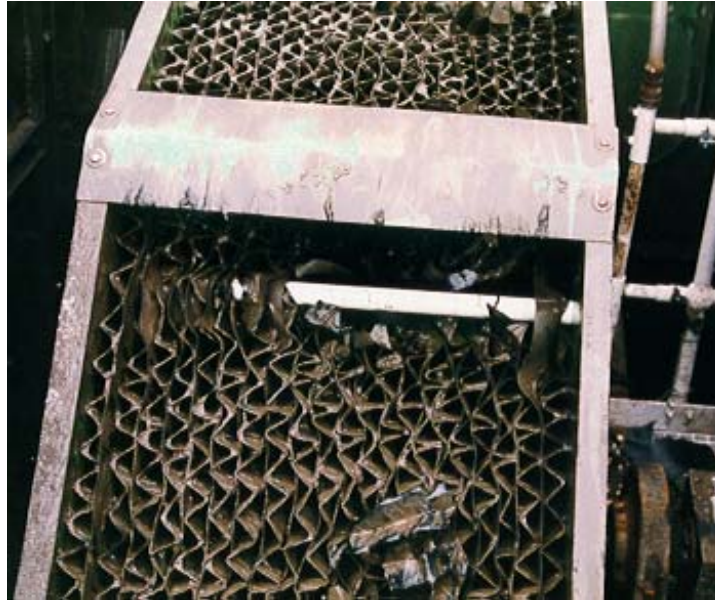
Figure 6 Loss of media pack due to tearing of HD polypropylene media panels

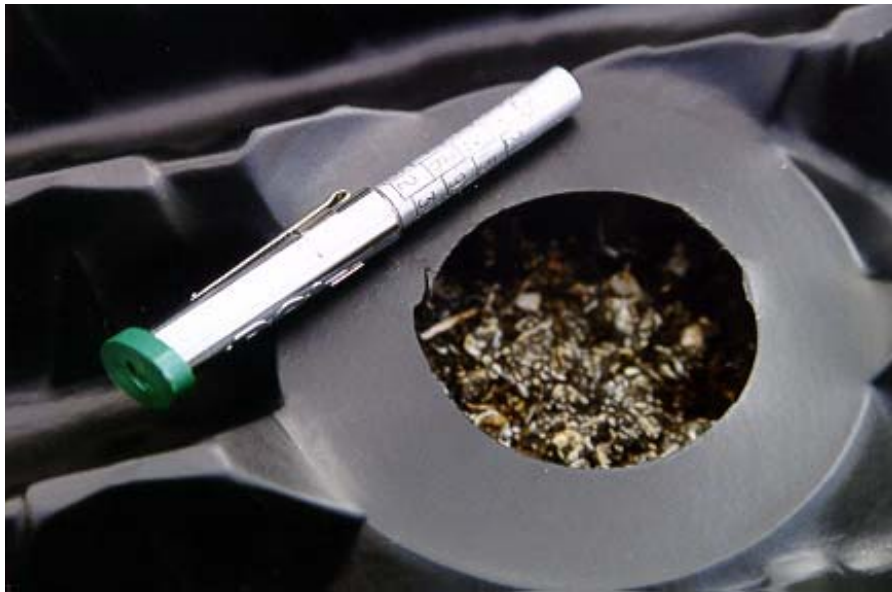
Figure 7 Stress concentrations on the media panel

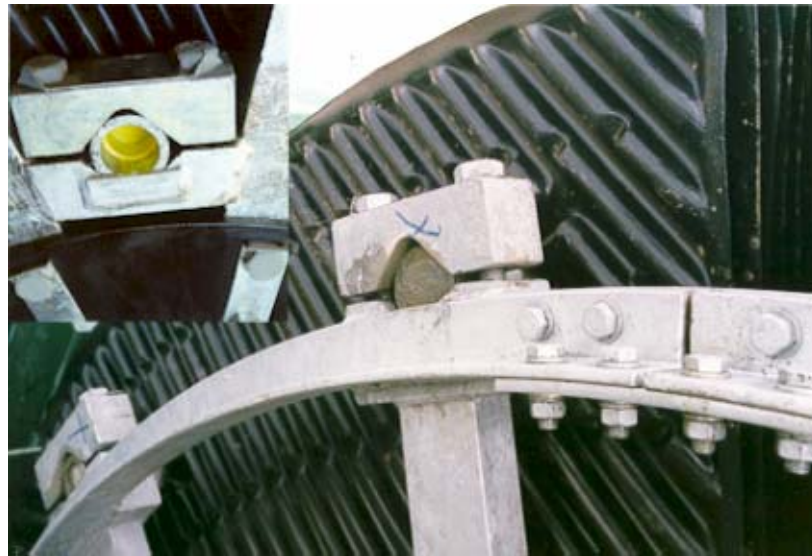
Different manufacturers approach this problem in a number of ways. The approach embraced by Cranfield University, is to provide a four point, line contact, method of support by employing a double "vee block" design illustrated in figure 9. Furthermore, the wall thickness of the through rod has to be sufficiently rigid so as not to allow crushing of the tube wall, therefore the tightening torque of the clamping bolts is also part of the design specification, together with the axial length of the vee block. Best practice relating to the design of through rod end clamps is governed by the design of the media pack support frame, moreover, most manufacturers acknowledge the loading pattern described above will give rise to bolt loosening. Therefore positive mechanical bolt locking is highly recommended.

Figure 9 Four point line contact 'vee' block

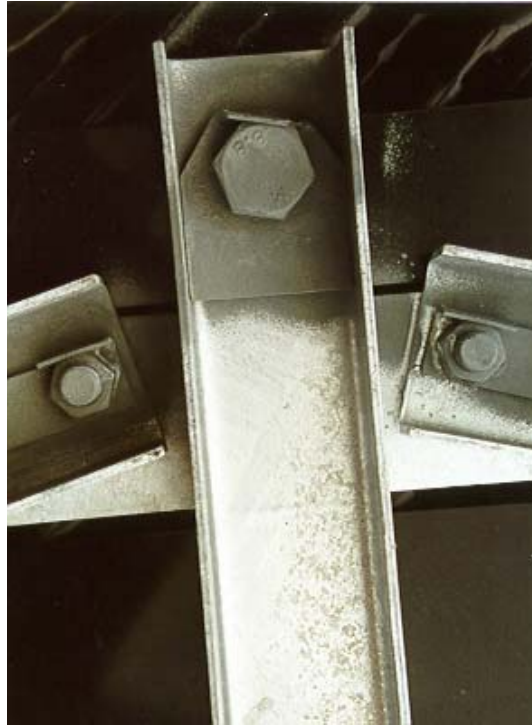
Furthermore, to combat loss of bolt tightening torque use is made of positive locking for both nuts and bolts, see figure 10. Initial difficulties of properly aligning tab washers has been over come by pre-forming the washer on a jig there by ensuring the "upturned" section always aligns with the flat of the nut or bolt.

Figure 10 Use of positive locking plates on nuts and bolts

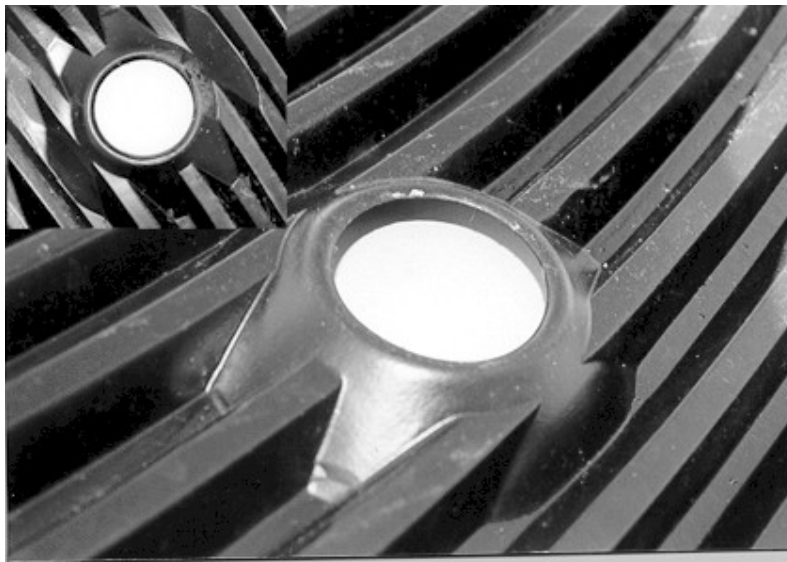
To overcome this problem, the particular region has been strengthened and more stringent finishing requirements are requested, see figure 11. Furthermore, it was noted that the thickness of high-density polypropylene employed (0.5mm) was insufficient to avoid tearing and retain rigidity. An increased thickness of 0.9mm is currently successfully employed.

Figure 11 Strengthened ring on media panel
